1st Virtual Conference on Structural Integrity - VCSII

AE fatigue experiments on tanks test samples with artificial pre-cracking

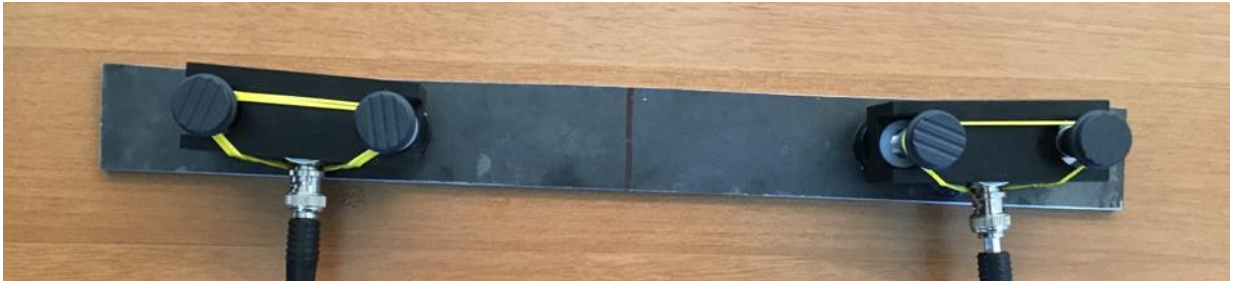
Fig. 1. A specimen with the sensors attached.

Experiments proceeded in load control, with a constant monitoring on displacements. The piezoelectric sensors were applied directly on the specimens, as showed in Figure 1.

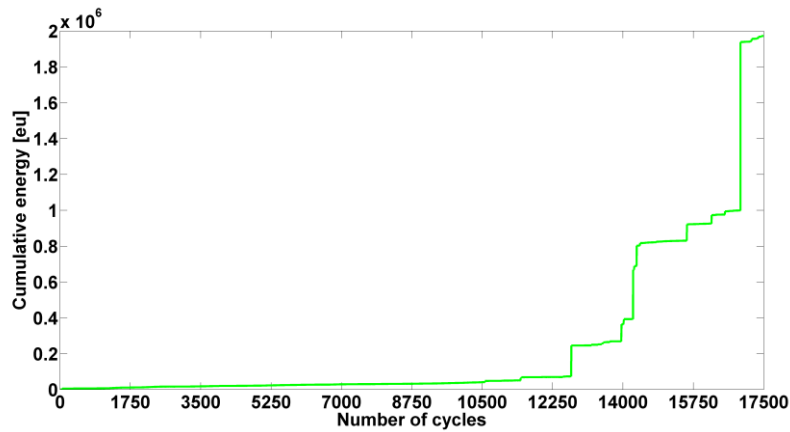
Fig. 5. Cumulative energy vs number of cycles for the type 1 notched specimen.

The graph of the Cumulative number of hits vs the Number of cycles (Figure 4) and the graph of the Cumulative energy vs the Number of cycles (Figure 5) present a stepped shape, smoother the first, definitely abrupt the second, but both related to isolated acoustic emissions at a high level of energy.

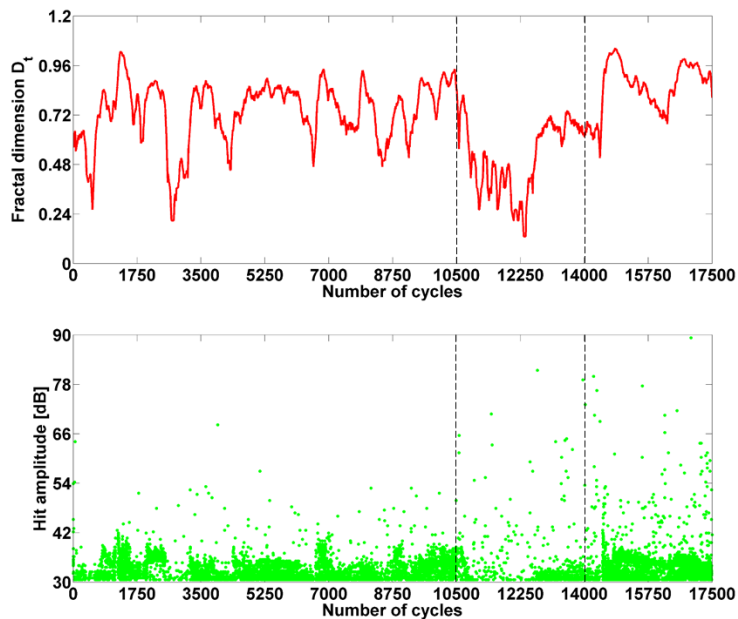
Fig. 6. Type 1 notched specimen, fractal dimension D_t of the registered hits over time above and their representation as green dots in a Amplitude vs Time diagram below.

Fractal analysis associates a physical interpretation to the fractal dimension D_t of a signal: when $D_t = 1$ the system has a completely disordered pattern of sources, when D_t tends to 0 the system is evolving towards a better organized structure of damage. Figure 6 compares the fractal dimension D_t of the registered hits over time (above) with their representation as green dots in a Amplitude vs Time diagram (below). As can be observed, D_t oscillates throughout the test, which seems to suggest a step-wise progression of damage. When the specimen is approaching to failure (the portion between the dashed lines), a low value of D_t is encountered over many cycles, with a lower occurrence of emissions but at a higher energy level. This stepped progression agrees very well with the crack nucleation and its evolution to a fully developed crack.

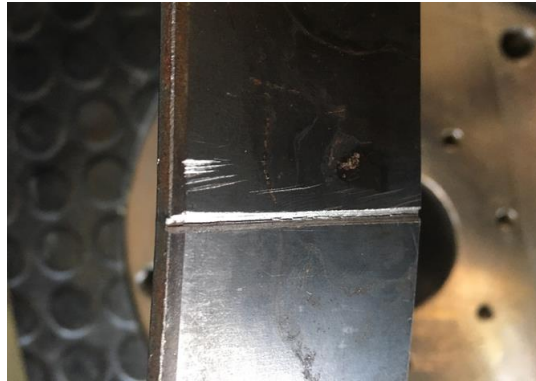
Fig. 7. A fatigue crack is well visible along the slit of the type 2 notched specimen.

Fracture occurred after 2735 cycles at 800 N for type 2 notch (Figure 7). The graph of the Cumulative number of hits vs the Number of cycles (Figure 8) and the graph of the Cumulative energy vs the Number of cycles (Figure 9) show homogeneously rising curves. This suggests a rapid and continuous process for damage evolution. Fractal analysis, which can capture the spotted nature of several phenomena, is omitted for type 2 notch.
